# Full handover protocol

| Object/address | 118 Maple Court, Apartment 5B, 02118 Boston, US |
| Handover type | Move-out |

| Case title | Move-out handover at Maple Court |

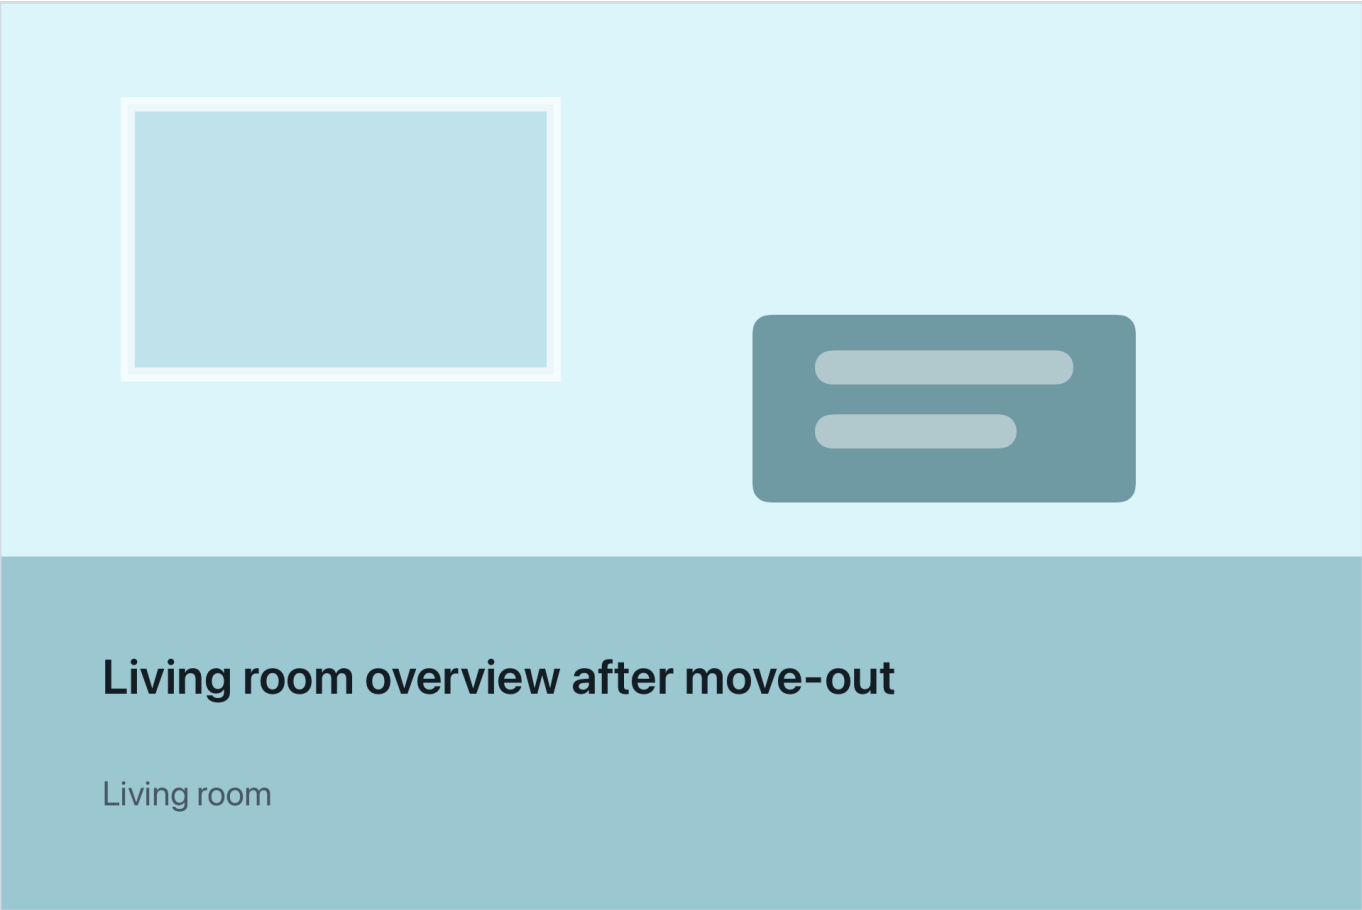
Appendix A1

Checked in daylight after furniture removal; outlets, windows and floor condition reviewed together.

Walls = Fair; note: Normal wear near picture hooks; no fresh paint touch-up agreed on site.

Reference: 55CC0F51-BE13-42E1-9CE9-A0F970419A88  
captured at: Jun 2, 2026 at 10:04 AM  
Note: Living room overview after move-out
